NEW YORK STATE DEPT OF ENVIRONMENTAL CONSERVATION ALBANY F/6 13/13
NATIONAL DAM SAFETY PROGRAM. MORGAN LAKE DAM (INVENTORY NUMBER --ETC(U)
SEP 80 E O'BRIEN

REPORT DOCUMENTATION PAGE		READ INSTRUCTIONS BEFORE COMPLETING FORM
1. REPORT NUMBER	2. GOVT ACCESSION NO.	3. RECIPIENT'S CATALOG NUMBER
	AD-A092039	
4. TITLE (and Subtitle) Phase I Inspection Report Morgan Lake Dam Hudson River Basin, Dutchess County, New York Inventory No. 787		5. TYPE OF REPORT & PERIOD COVERED Phase I Inspection Report National Dam Safety Program

PHASE I INSPECTION REPORT
NATIONAL DAM SAFETY PROGRAM
MORGAN LAKE DAM
I.D. NO. N.Y. 787
D.E.C. NO. 685
HUDSON RIVER BASIN
DUTCHESS COUNTY, NEW YORK

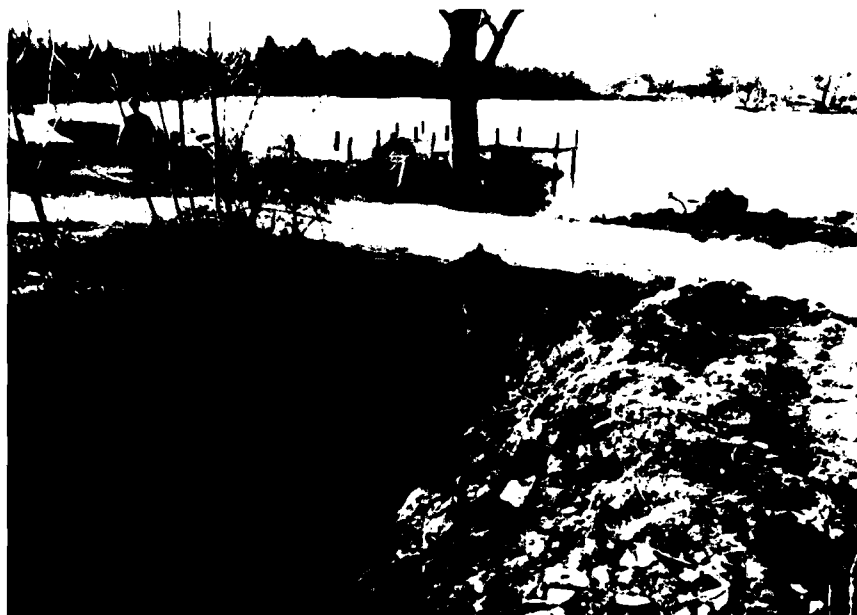
e. Downstream Channel. The spillway downstream channel is in poor condition (Figure 5). Debris was found to exist along the channel length. Immediately downstream of the pipe, the side slopes are relatively steep and contain large trees. Channel flow is diverted along the toe of the embankment, which could cause erosion and resulting slope instability (Figure 6).

5. VIEW OF DOWNSTREAM SPILLWAY CHANNEL.
